Bulk Tank, Inc.

CHECK VALVE OPERATIONAL TESTING:

TEST: One each of a BTI, Competitor 1 and Competitor 2 check valves to be mounted in a test stand to be tested simultaneously for operational longevity and reliability.

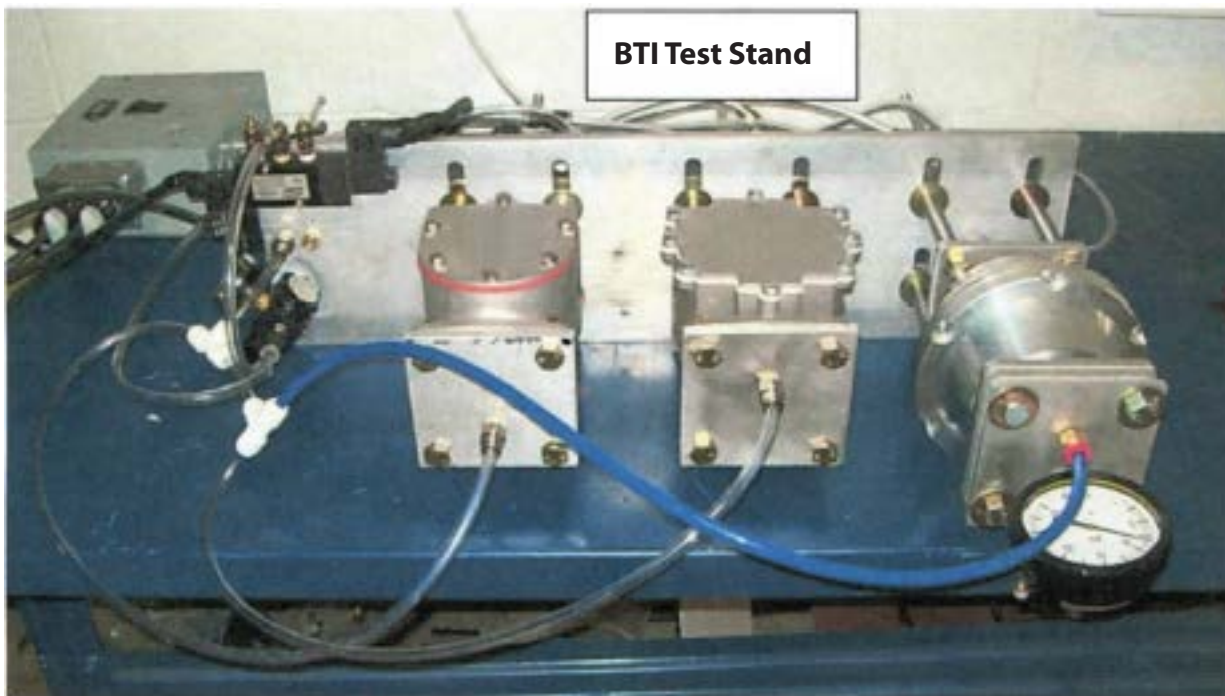
PROCEDURE: The valves will be slammed shut with 20 psi by applying air pressure to the back of the valve, The valve will then be completely opened with an air cylinder. This will constitute a complete cycle.

The valves and counter will be controlled via a PLC controller.

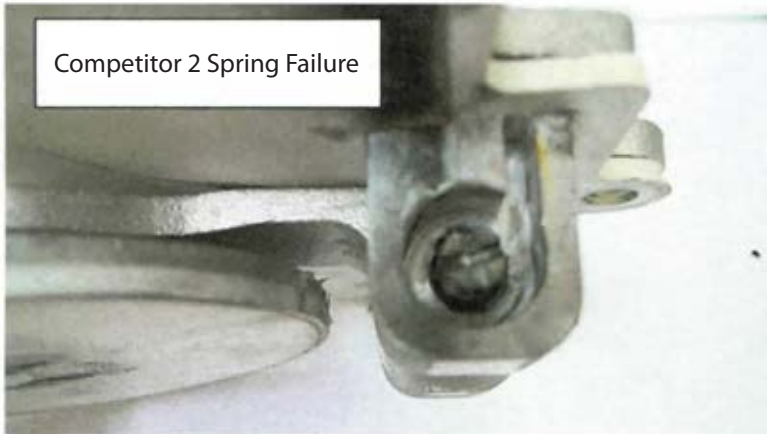
3/28/12

At 15,271 the Competitor 2 valve experienced a single spring failure. This slowed the valves ability to close. The valve was allowed to continue the test.

The BTI and Competitor 1 valves continued to function normally.

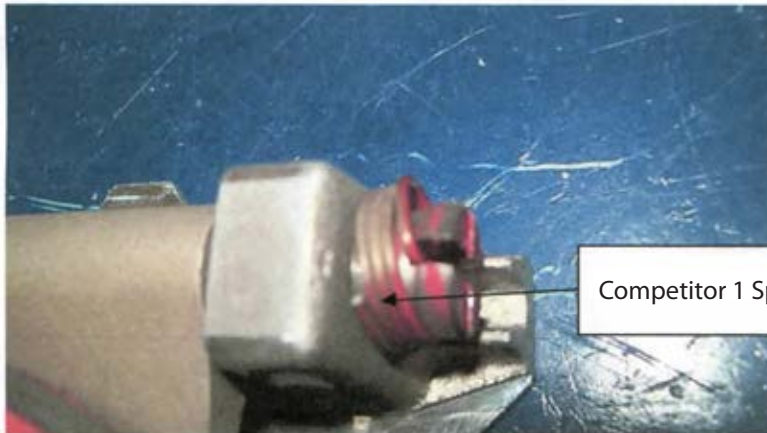
3/30/12

The Competitor 1 valve experienced a single spring failure at 28,000 cycles and slowed the valves ability to close.

The valve was allowed to continue the test.

At 32,046 the Competitor 2 valve would no longer hold 20 psi. Both torsion springs in the unit had failed and would not allow the poppet to close.

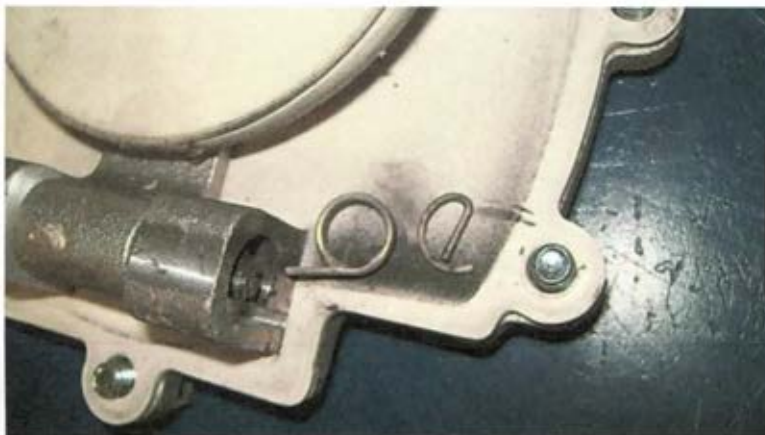
Competitor 2 valve with both torsion springs broken. Valve would not hold pressure after 32,046 cycles.

AT 32,046 THE COMPETITOR 2 VALVE HAS FAILED.

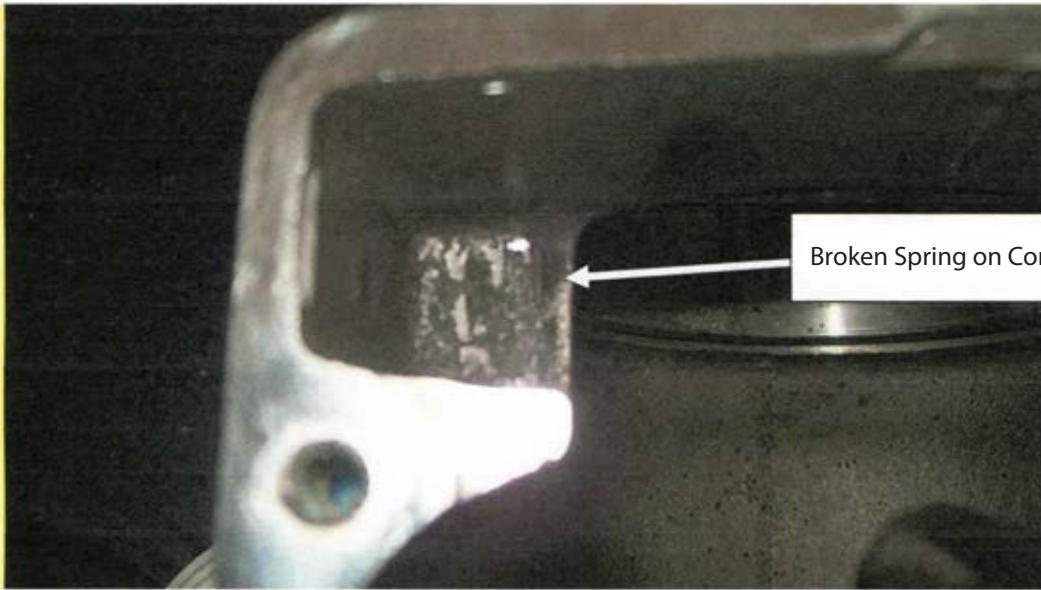
Broken Spring on Competitor 1 Valve

At 45,000 cycles the Competitor 1 valve experienced the second torsion spring failure that left the valve unable to Close

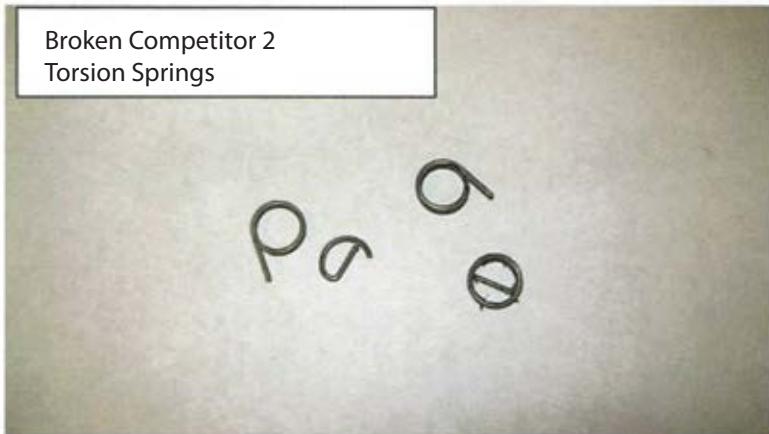
Broken Competitor 2 Torsion Springs

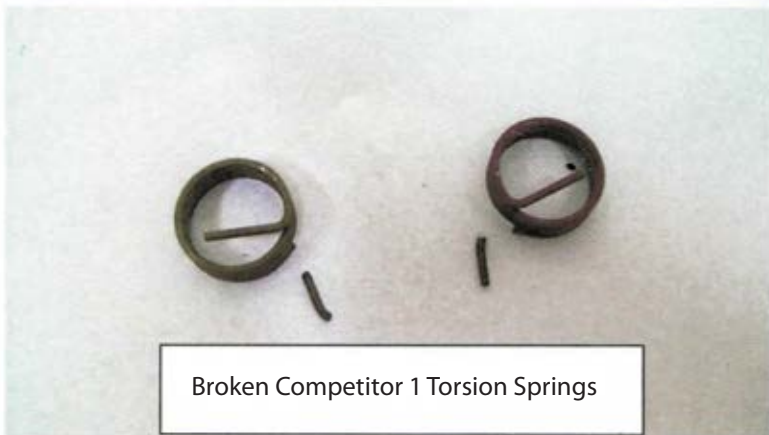
Broken Competitor 1 Torsion Springs

AT 45,000 CYCLES TO THE COMPETITOR 1 VALVE HAS FAILED.

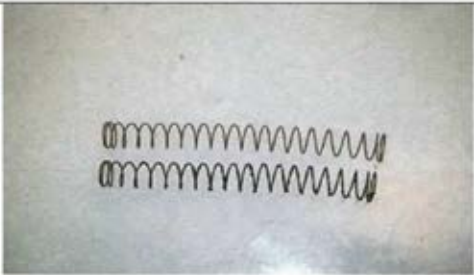
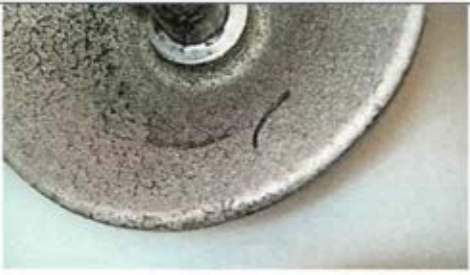
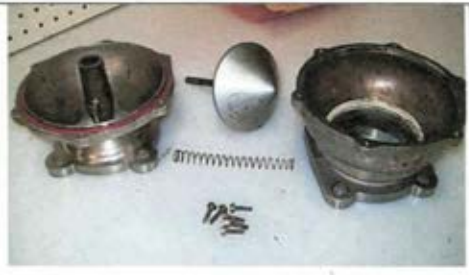
OLD SPRING VS NEW (New on Top)	PARTICULATE ON BACK SIDE OF POPPET	EXPLODED VIEW
